Environmental Assessment for HUD-funded Proposals

Project Identification: Farm Trace Bypass Storm Sewer and Detention Basin

Project Name: Farm Trace Bypass Storm Sewer and Detention Basin

Project Location: Steger Road from Farm Trace Drive to Central Park Avenue,

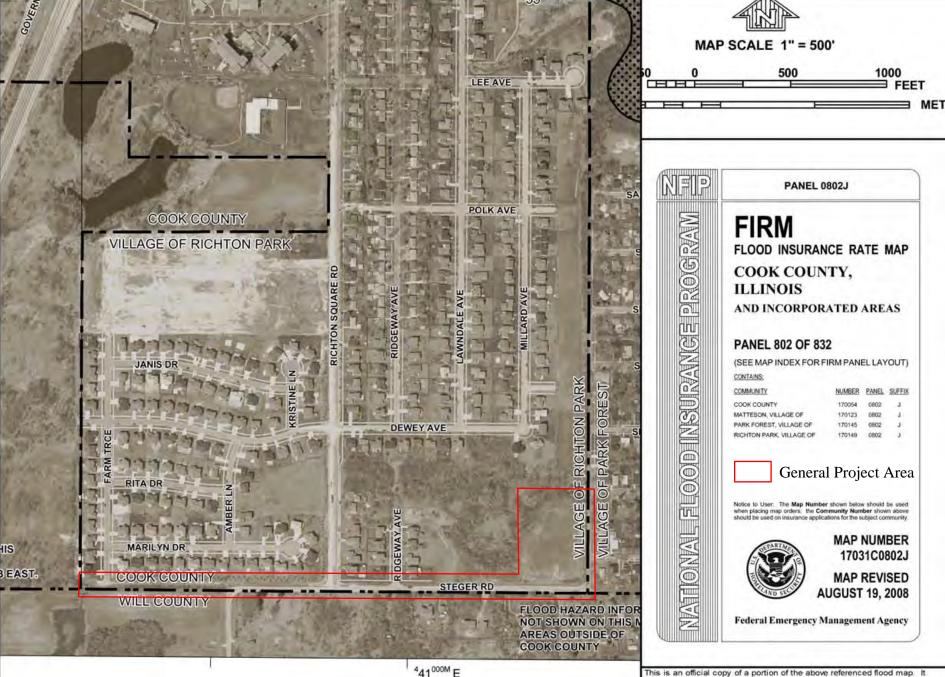
Figure 4: FEMA FIRMette

This is an official copy of a portion of the above referenced flood map. It was extracted using F-MIT On-Line. This map does not reflect changes or amendments which may have been made subsequent to the date on the title block. For the latest product information about National Flood Insurance Program flood maps check the FEMA Flood Map Store at www.msc.fema.gov

The FIRM (Figure 4) depicts the entire area within the project limits as Zone X, areas outside of the 100 and 500-year floodplains.

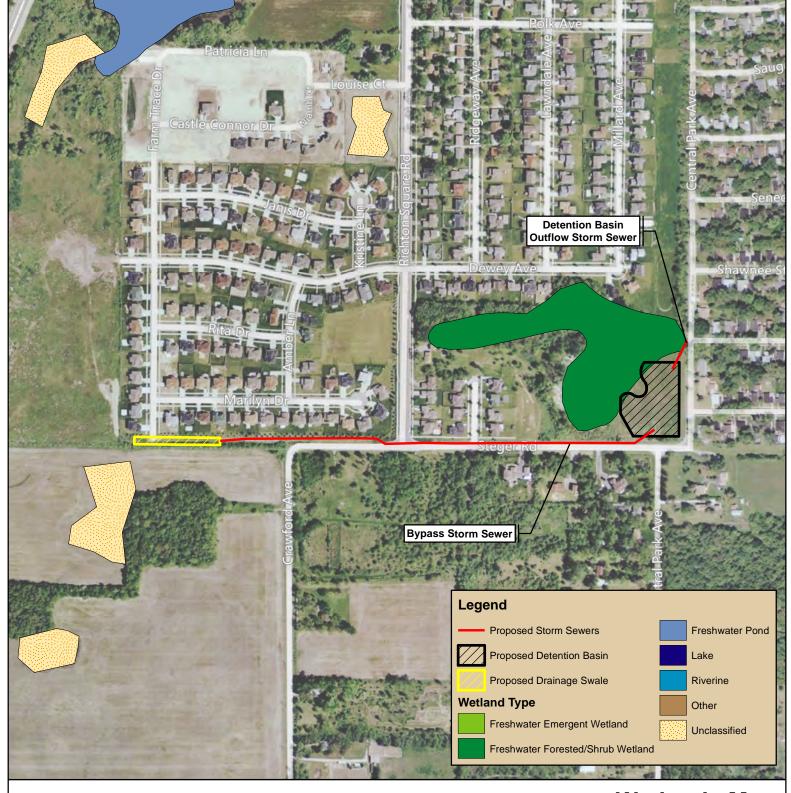
Figure 5: Wetlands Map

Wetlands Map

Data Source(s):
Ducks Unlimited Draft
National Wetlands
Inventory Update
(accessed:
http://www.ducks.org/
conservation/glaro/
glaro-gis-nwi-update-data),
Bing Maps Hybrid

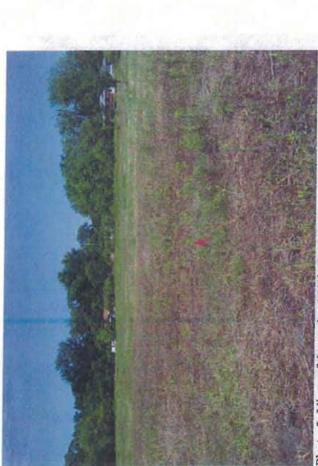
Photo 5: View of datapoint 1-6 facing southeast (6/3/10).

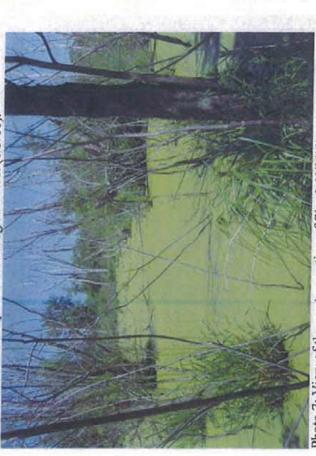
Photo 7: View of the center portion of Site 1 (6/3/10).

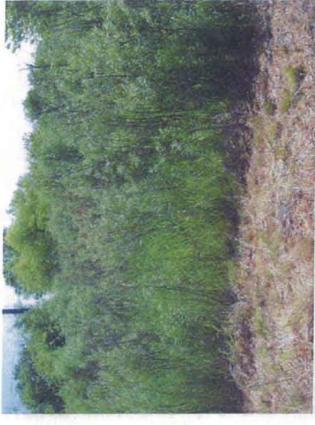
Photo 6: View of Site 1, datapoint 1-5 facing west (6/3/10).

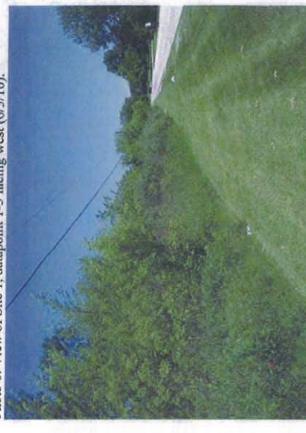
Photo 8: View of the south side of Site 1, facing east along Steger Road (6/3/10).

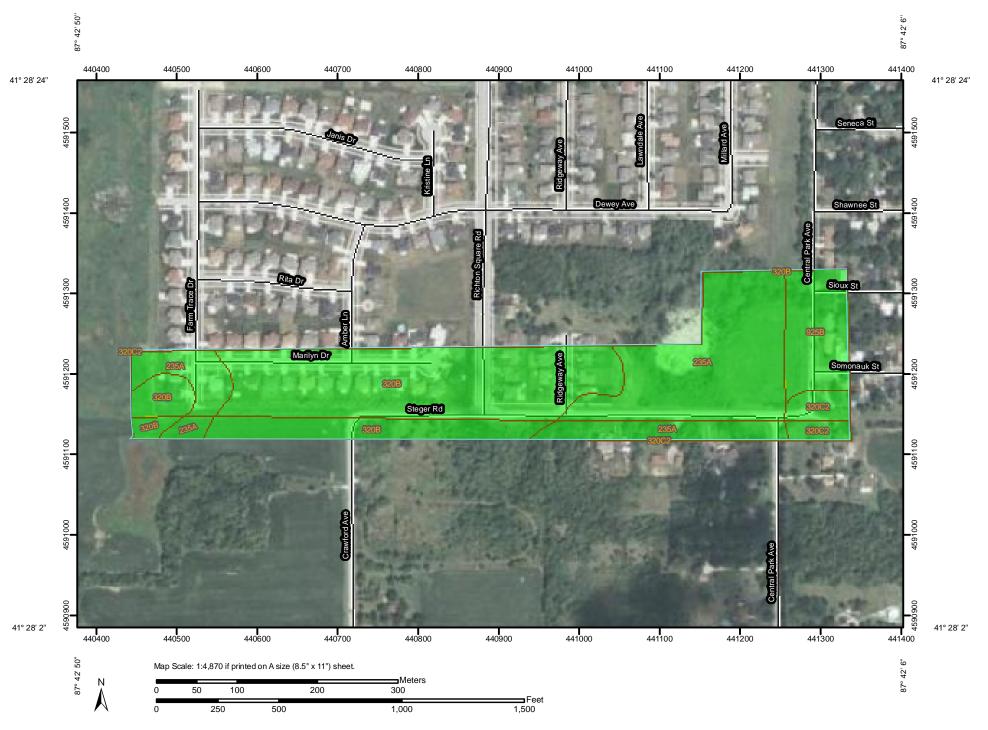
NRCS Soil Suitability

Corrosion of Concrete

Soil Suitability	1	The Natural Resources Conservation Service (NRCS) classifies the soils in the proposed project work areas as having a low potential for corrosion of concrete (see documentation in Appendix H).
	4	The soils in the proposed project work areas are classified as "very limited" for shallow excavations because of a high groundwater table (see documentation in Appendix H). It is likely that water would have to be pumped out of the trenches to facilitate proper bedding of the pipe (see Conditions for Approval above or Mitigation Measures Recommended below).
		Source: NRCS, Web Soil Survey, http://websoilsurvey.nrcs.usda.gov
Hazards and Nuisances including Site Safety	1	The proposed project area contains no unusual hazards, nuisances or safety concerns.
Energy Consumption	1	The proposed project would not consume a significant amount of energy, except for a typical amount during the construction phase.
